## PRELIMINARY DRAWINGS NOT FOR CONSTRUCTION

WEATHER SHIELD WINDOW REPAIR DETAIL - SILL SCALE : NTS

WINDOW REPAIR DETAIL - SILL

WEATHER SHIELD 8 WINDOW ELEVATION - REPAIR DETAIL

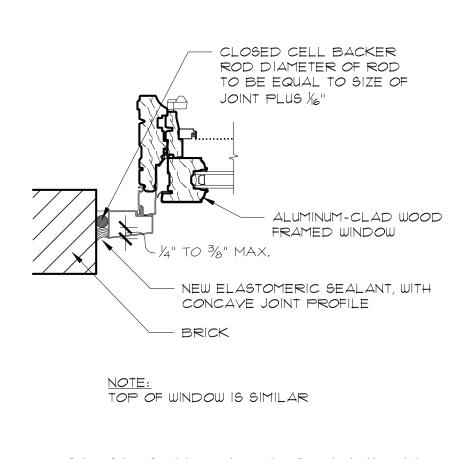
SEALANT REPLACEMENT

- MAKE SURE THAT JOINT IS CLEAN, DRY, AND FREE OF ANY ITEMS WHICH MAY INHIBIT BONDING OF SEALANT TO SURFACES.
- INSTALL CLOSED CELL BACKER ROD INTO JOINT, COMPRESSING ROD SLIGHTLY TO FIT, AND INSTALL ABOUT 1/4" INTO JOINT, BUT NO DEEPER THAN 3/4" INTO JOINT.

- ENSURE THAT BACKER ROD IS ADEQUATELY SECURED. INSTALL NEW SEALANT AS DIRECTED IN THESE DOCUMENTS AND IN ACCORDANCE WITH MANUFACTURER'S INSTALLATION GUIDELINES.

- ALLOW THE SEALANT TO CURE IN ACCORDANCE WITH MANUFACTURER'S INSTALLATION GUIDELINES, BUT NO LESS THAN 12 HOURS. DO NOT USE WINDOWS DURING CURE TIME.
- 5. SEALANT COLOR GELECTION BY ARCHITECT.

- SEALANT SHALL NOT BE INSTALLED WHEN THE TEMPERATURE IS BELOW 40 DEGREES OR EXPECTED TO GO BELOW 40 DEGREES WITHIN 12 HOURS OF INSTALLATION. PREFERRED TEMPERATURES ARE IN THE MID 705 TO MID 805, BUT SEALANT INSTALLATION MAY PROCEED WITH TEMPERATURES IN THE RANGE OF 55 DEGREES FAHRENHEIT TO 95 DEGREES FAHRENHEIT.

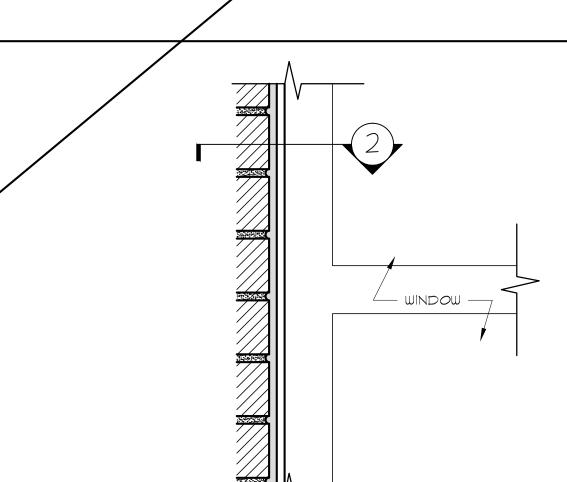
- REMOVE OLD SEALANT FROM JOINT BETWEEN WOOD FRAME WINDOWS AND BRICK.
- 2. ACCEPTABLE METHODS FOR REMOVAL INCLUDE UTILITY KNIFE GRINDING WHEEL, ETC. DO NOT USE CHIPPING HAMMERS OR OTHER IMPACT METHODS.
- 3. COMPLETELY REMOVE ALL TRACES OF OLD CAULK, AND REMOVE ANY DUST, DEBRIS OR OTHER ITEMS WHICH MIGHT INTERFERE WITH BOND OF NEW SEALANT.
- 4. SOLVENT CLEANING IS REQUIRED TO ADEQUATELY PREPARE JOINTS FOR NEW SEALANT.
- 4 EXISTING JOINT DEMOLITION DETAIL

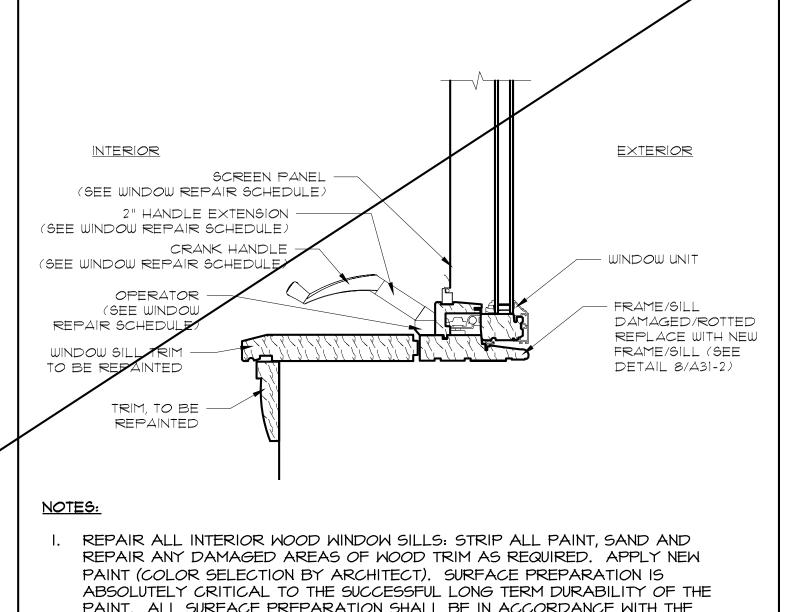
PAINT. ALL SURFACE PREPARATION SHALL BE IN ACCORDANCE WITH THE PAINT MANUFACTURER'S INSTALLATION GUIDELINES.

2. APPLY A PARAFFIN OR OTHER DRY LUBRICANT TO THE WEATHER STRIPPING OF EACH WINDOW UNIT. DO NOT USE OILY LUBRICANTS.

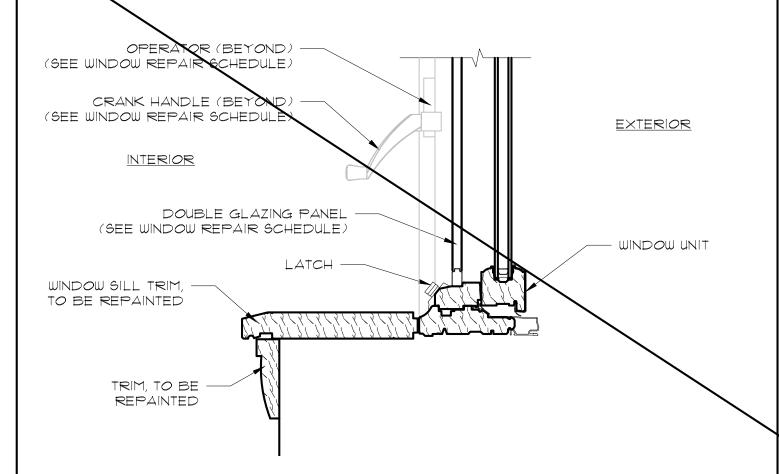
- REPAIR ALL INTERIOR WOOD WINDOW SILLS: STRIP ALL PAINT, SAND AND REPAIR ANY DAMAGED AREAS OF WOOD TRIM AS REQUIRED. APPLY NEW PAINT (COLOR SELECTION BY ARCHITECT). SURFACE PREPARATION IS ABSOLUTELY CRITICAL TO THE SUCCESSFUL LONG TERM DURABILITY OF THE PAINT. ALL SURFACE PREPARATION SHALL BE IN ACCORDANCE WITH THE PAINT MANUFACTURER'S INSTALLATION GUIDELINES.
- 2. APPLY A PARAFFIN OR OTHER DRY LUBRICANT TO THE WEATHER STRIPPING OF EACH WINDOW UNIT. DO NOT USE OILY LUBRICANTS.

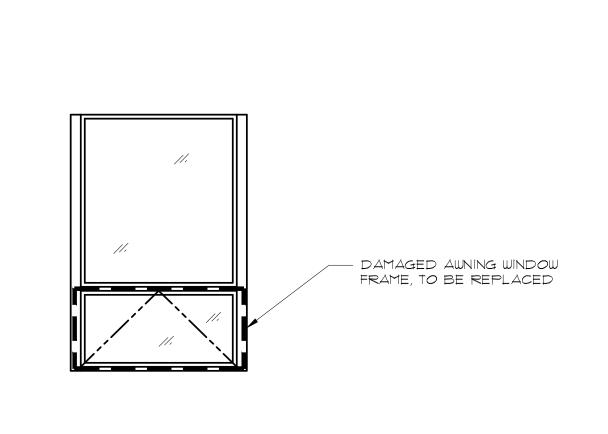
REMOVE WINDOW SASH, AND OTHER NECESSARY WINDOW COMPONENTS IN ORDER TO REPLACE THE AWNING WINDOW FRAME SHOWN DASHED. PROTECT AND REPLACE ALL EXISTING WINDOW COMPONENTS REMOVED IN ORDER TO REPLACE FRAME.
